# Manhole Inspection Summary

Manhole # S29K\_\_011MH

Insp Date: **11/16/08 10:39 AM**

**Location** Address: **1055 W Barre St**

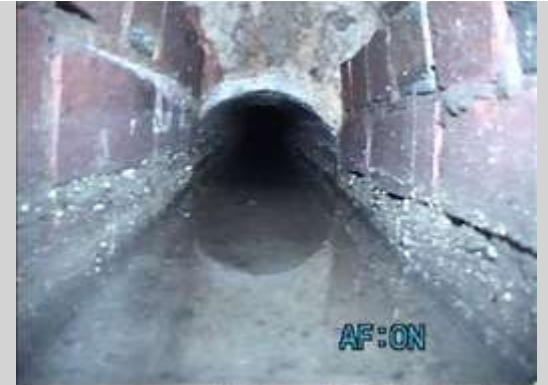
12 O'Clock Outflow

8 in. Circular Gravity Sewer  
Pipe Out @ 12 O'Clock

Pipe Height: **8.4** (in.) Rod and Bar (Angled)  
Pipe Material: **Clay** ☐ Pipe Lined  
Invert Depth: **10.10** (ft.) Flow Characteristics: **Slow**  
Deposits: ☒ None ☐ Mud ☐ Sludge ☐ Debris ☐ Grease  
Silt Depth: **0** (in.) Deposits Extent:  
Infiltration: **None** Pipe Seal Cond: **Sound**

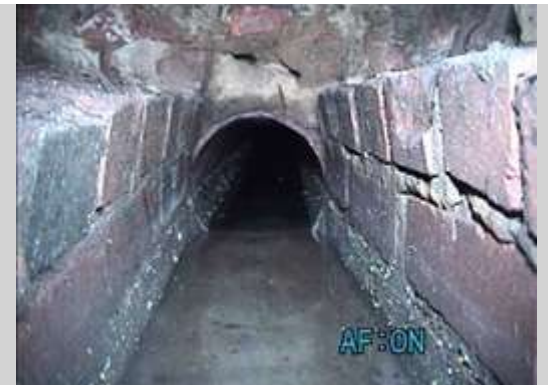
6 O'Clock Inflow

8 in. Circular Gravity Sewer  
Pipe In @ 6 O'Clock

Pipe Height: **8.4** (in.) Rod and Bar (Angled)  
Pipe Material: **Clay** ☐ Pipe Lined  
Invert Depth: **9.98** (ft.) Flow Characteristics: **None**  
Deposits: ☒ None ☐ Mud ☐ Sludge ☐ Debris ☐ Grease  
Silt Depth: **0** (in.) Deposits Extent:  
Infiltration: **None** Pipe Seal Cond: **Sound**
